LW405 laser writer troubleshooting manual

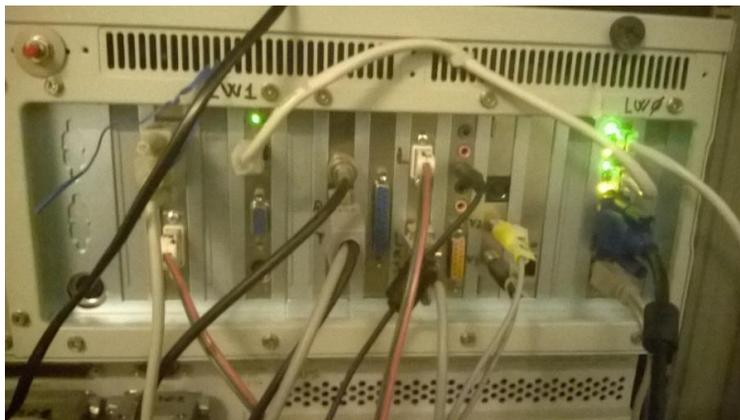
Fig. 1: Laser writer backside connections

The LW405 computer rack needs to be opened to check the LW1 board. This is kept above the XPS controller unit. Before opening the rack, the back connections need to be removed. The connections are as shown below:

Remove the VGA cable connection from LW0 to LW1 as indicated in fig. You may also consult the manual to verify the back connection labels.

Press the LW1 reset button. This is the red button at the left hand corner of fig. 1.

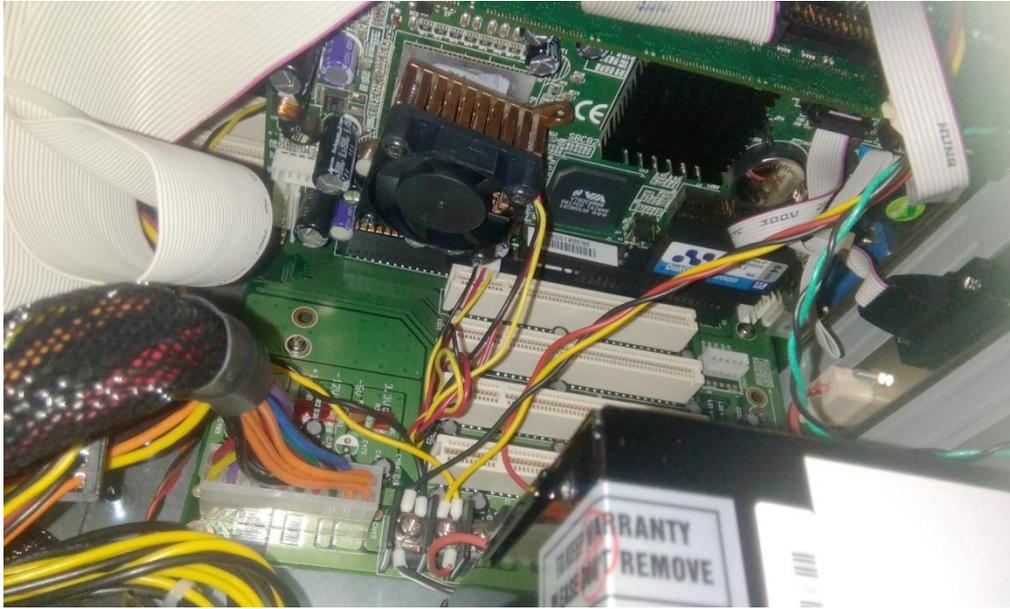
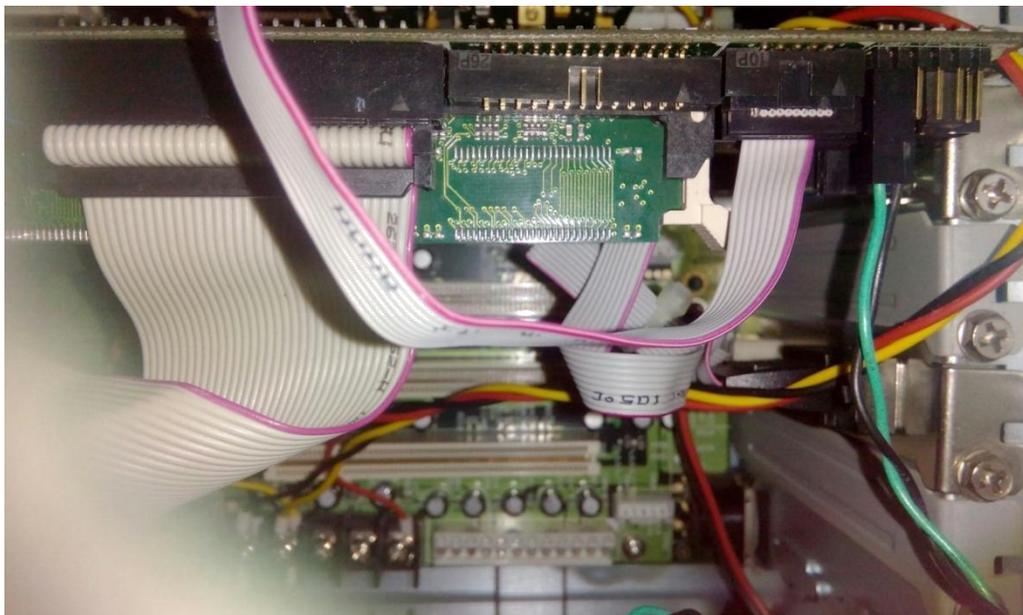
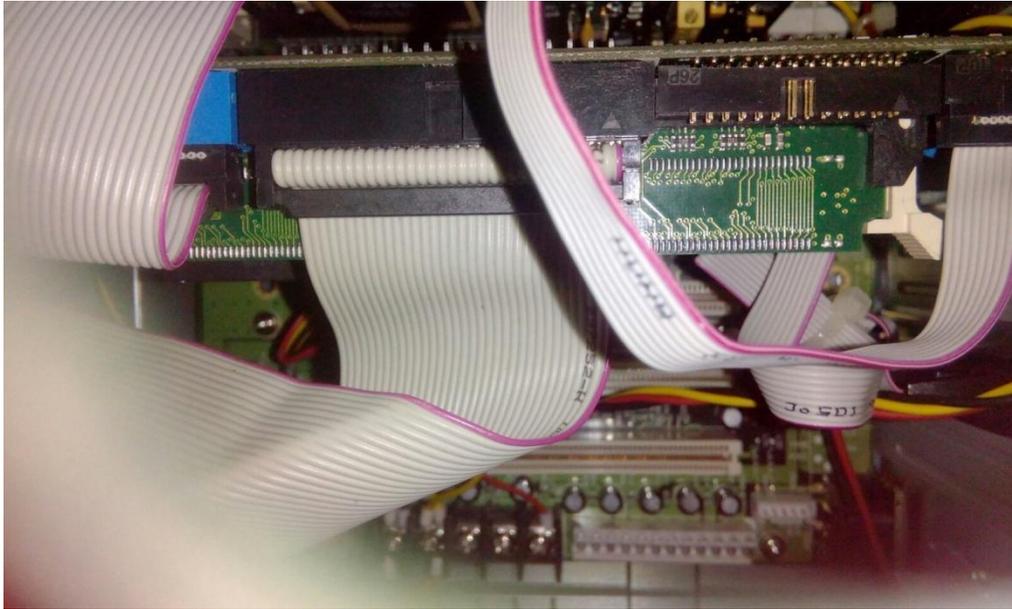
The “LW1 write timeout” message indicates that the affected module is LW1 that regulates the write control unit of the system. The fact that the system works/writes for a short duration after system restart and then starts giving errors may indicate a thermal problem. The LW1 CPU might be getting overheated. The LW1 heat sink could be detached from the LW1 CPU or the LW1 CPU fan could be damaged. In this case, the CPU has an in-built safety mechanism to shut down in order to protect itself from thermal damage. Once the CPU shuts down, the write control unit is disabled and the writing process cannot be resumed.

The LW1 board connections are as shown in the snapshots below:

Remove the LW1 board from the system. Remove and replace the CPU fan. If the heat sink lock pins are broken and damaged, replace them. Ensure that the broken pieces are first removed from the system. Clean the thermal paste with acetone. Apply fresh thermal paste on the heat sink and CPU and then place the heat sink on the CPU. Put the lock pins on the diagonally opposite ends of the heat sink. The spring on each lock pin ensures that adequate pressure is applied such that the heat sink has good thermal contact with the CPU but not large enough such that the PCB cracks.

Connect the LW1 board to the system. Keep the computer rack open. Complete the back connections and all other remaining connections. Start the system. Ensure that the LW1 fan is running and then close the rack. After loading Windows, wait for a few minutes. Perform a system check to ensure that the LW1 board is running perfectly:

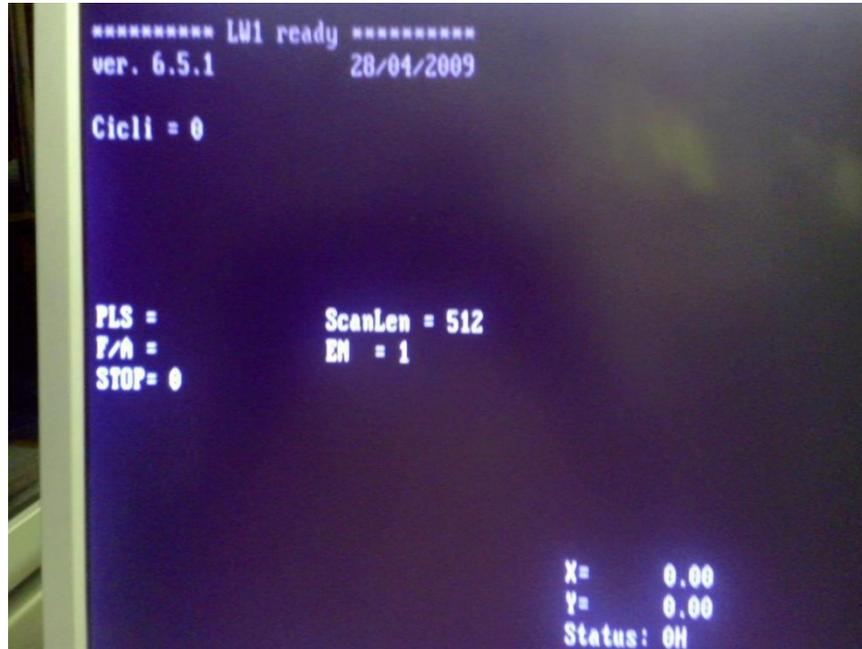
Fig. 5: LW1 system check message

If the LW1 is working perfectly, you will see the “LW1 ready” message as indicated in the image below:

This system check serves as a diagnostic test to ensure that the LW1 computer is working fine.
